Aftertreatment Fault Code
2014/03/28

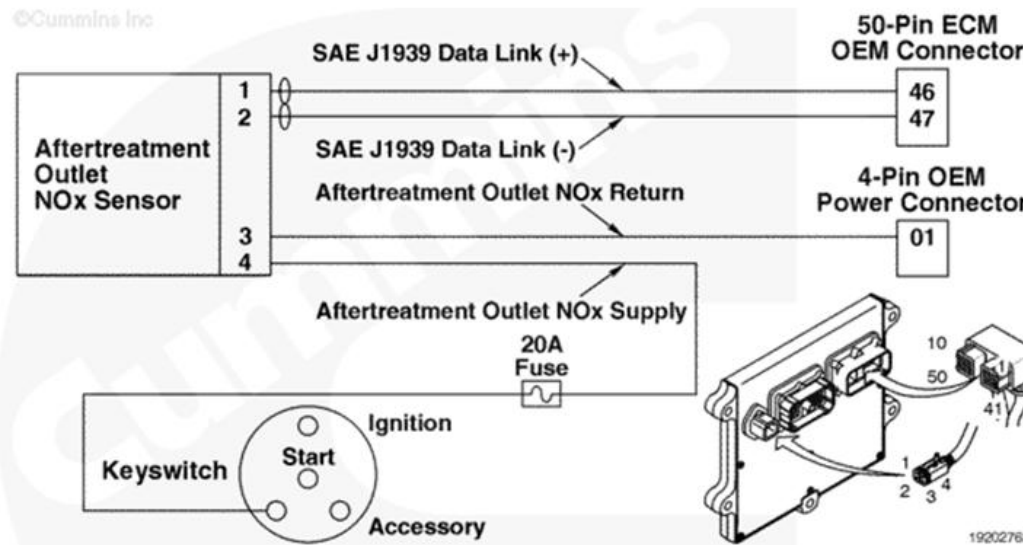
FC2771

- The aftertreatment outlet NOx sensor is not receiving power from the battery supply circuit in the OEM harness. This could be caused by an open circuit in the power supply wire, blown NOx sensor fuse, or low voltage supplied by the battery.
- Open return circuit on the Aftertreatment Outlet NOx Sensor battery return.
- Open or short circuit on the J1939 data link circuit between the engine ECM and aftertreatment outlet NOx sensor.
- Intermittent communications between the aftertreatment outlet NOx sensor and the primary engine ECM on the J1939 data link.

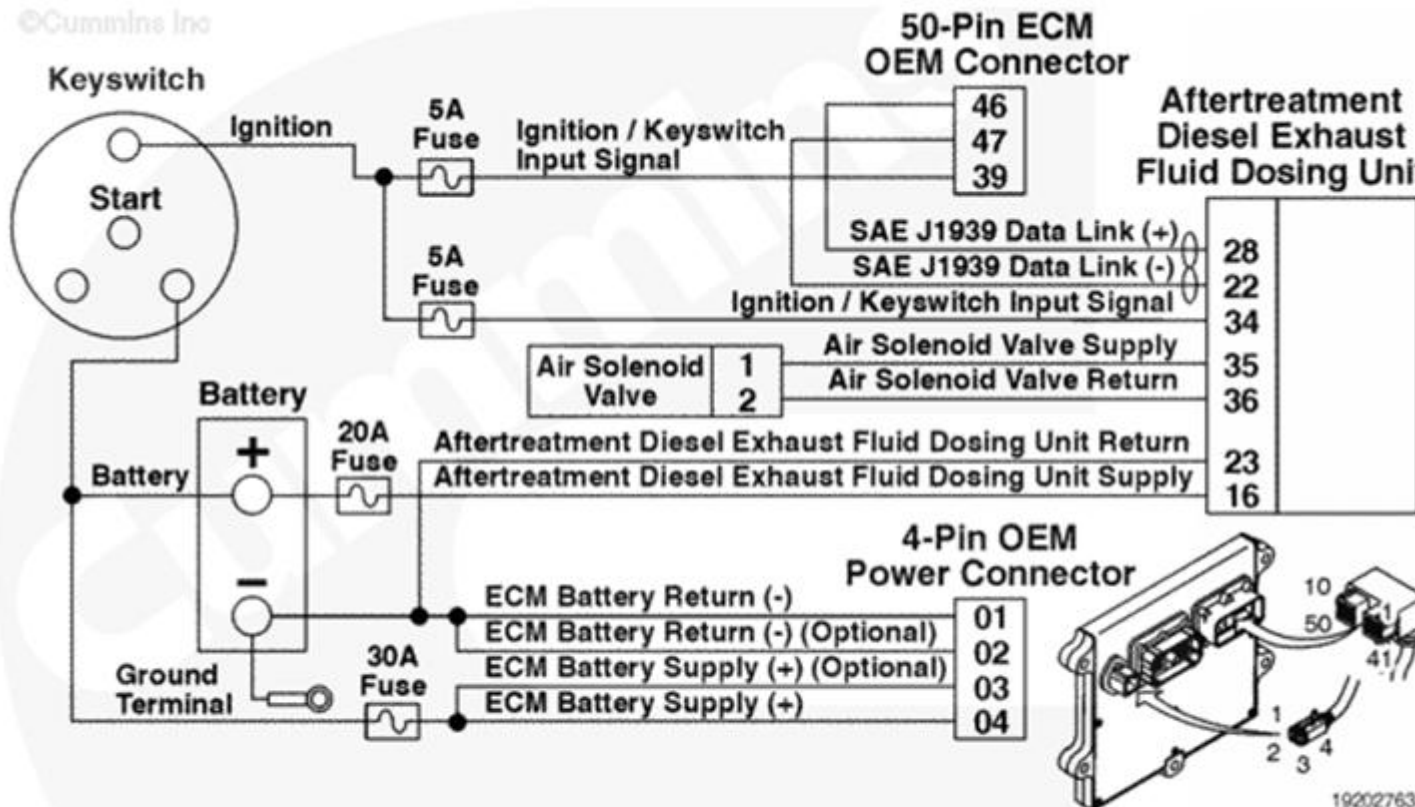
ISM11 CM876 SN - Aftertreatment Diesel Exhaust Fluid Dosing Unit Circuit

- Loss of battery voltage to the aftertreatment diesel exhaust fluid dosing unit (34 #) ,
- Shorted or open J1939 data link wiring between the aftertreatment diesel exhaust
- fluid dosing unit and the primary engine ECM(22#,28#)

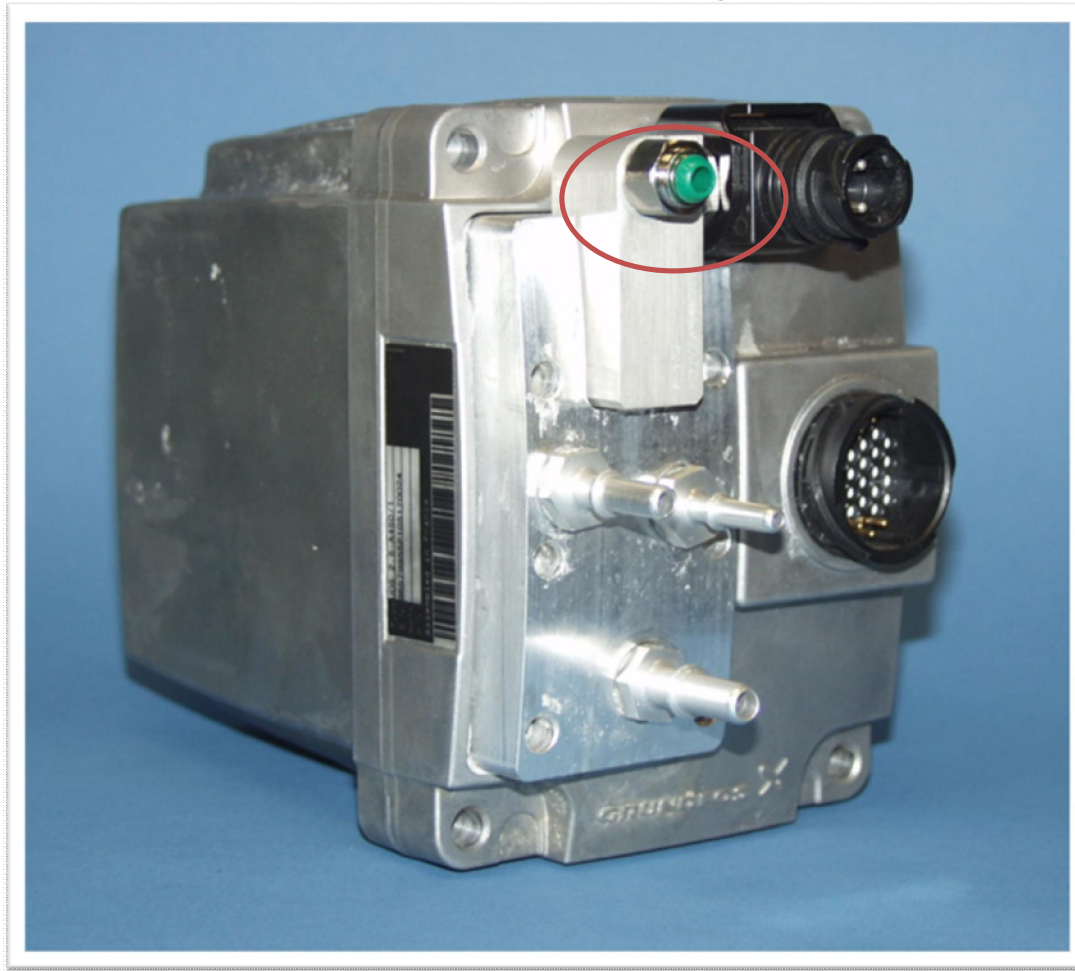
FC3548

- Make sure the air supplier line is good connected

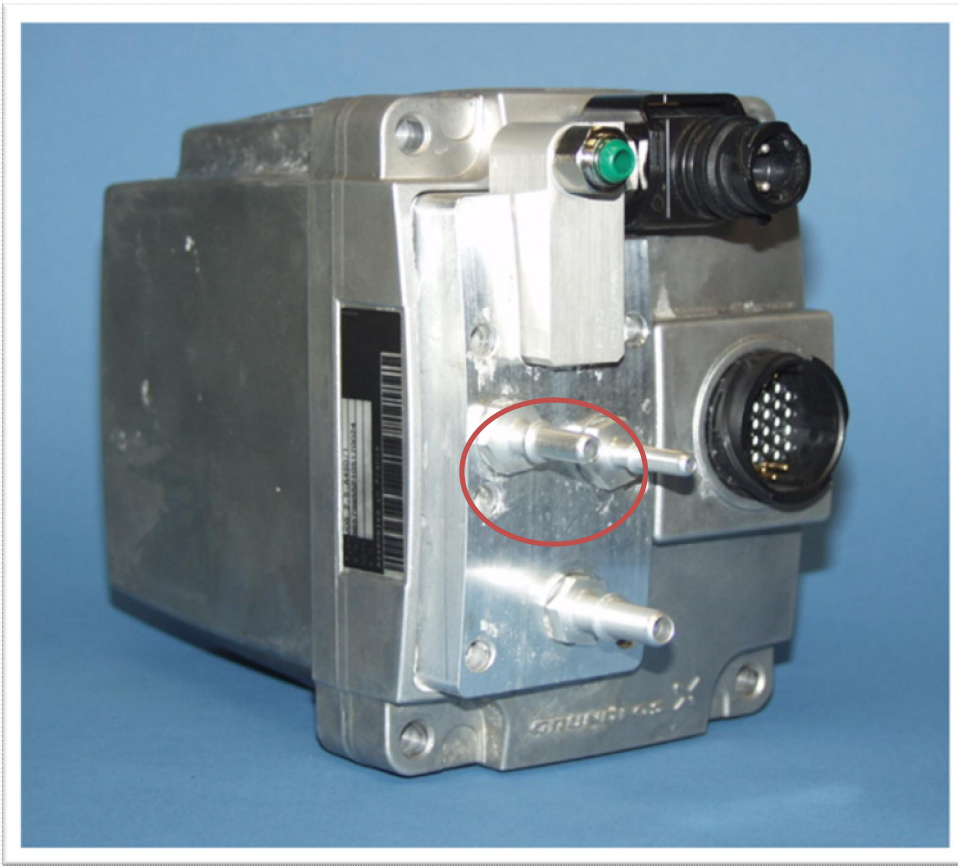
FC3575

- If The return line of dosing pump is being deformation, then the 3575 will be active.

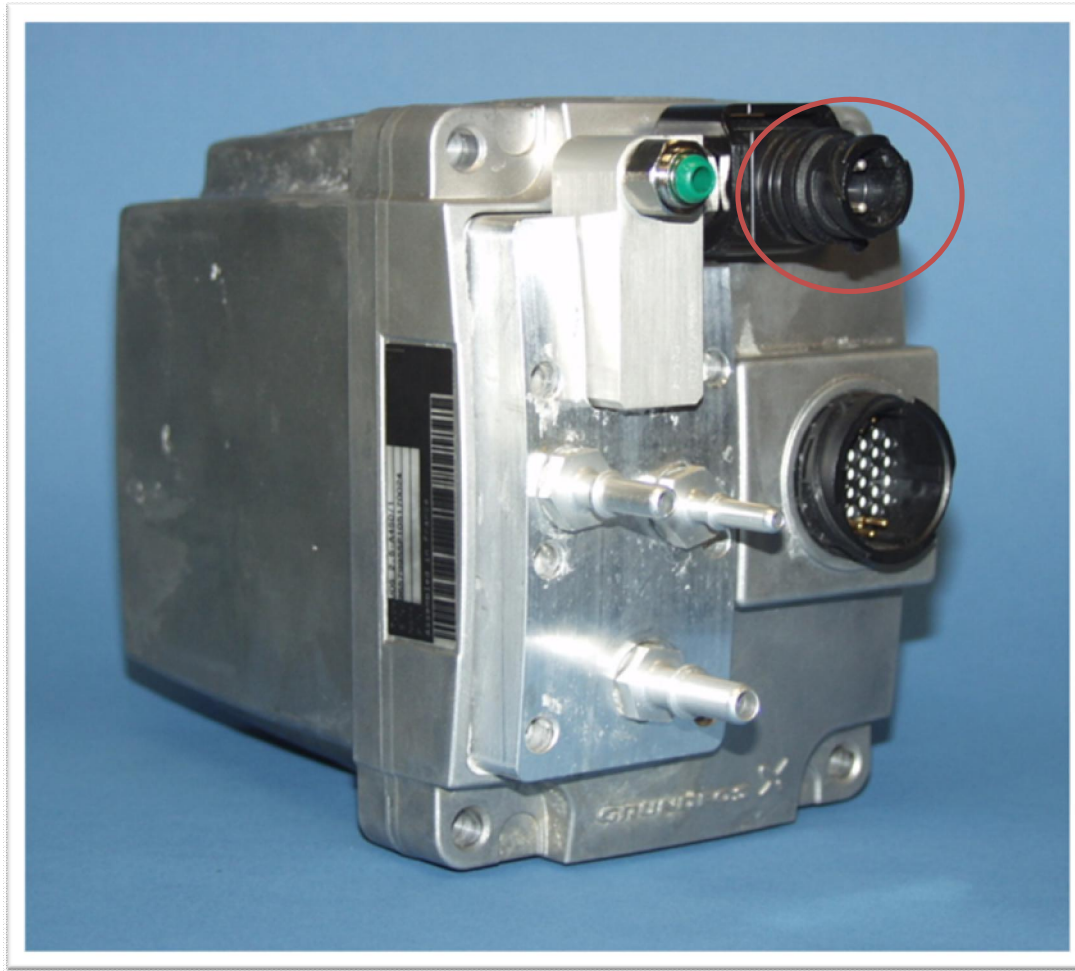
FC1698

- Check the air solenoid valve pin, make sure the wiring harness is normal

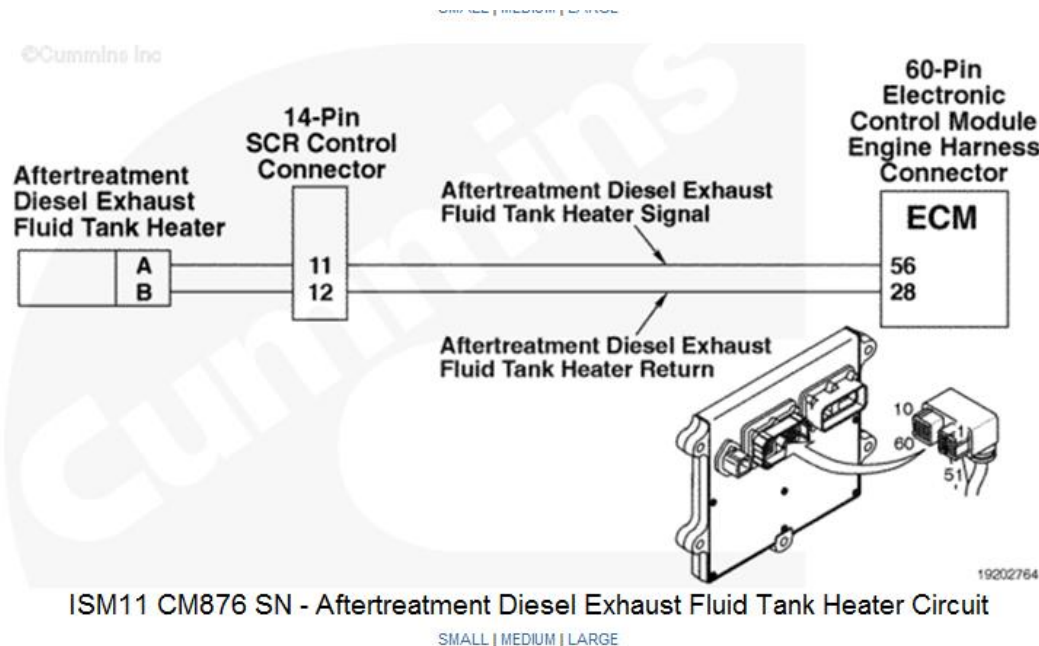
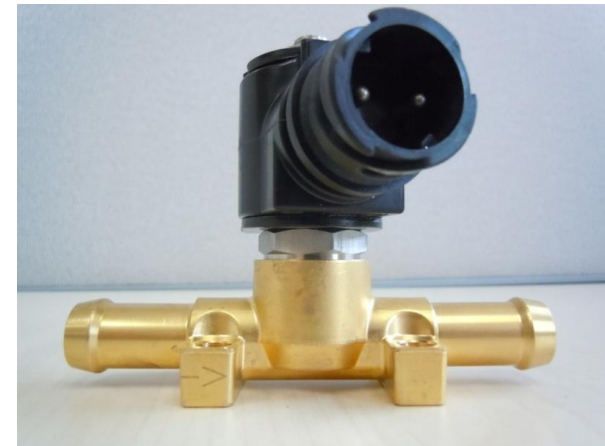
FC1683

- Diesel exhaust fluid tank heater relay signal wire not connected to the relay
- Diesel exhaust fluid tank heater relay return wire not connected to the relay
- Malfunctioning diesel exhaust fluid tank heater relay
- Open circuit in the diesel exhaust fluid tank heater relay signal wire
- Open circuit in the diesel exhaust fluid tank heater relay return wire
- Diesel exhaust fluid tank heater signal wire shorted to a voltage source.

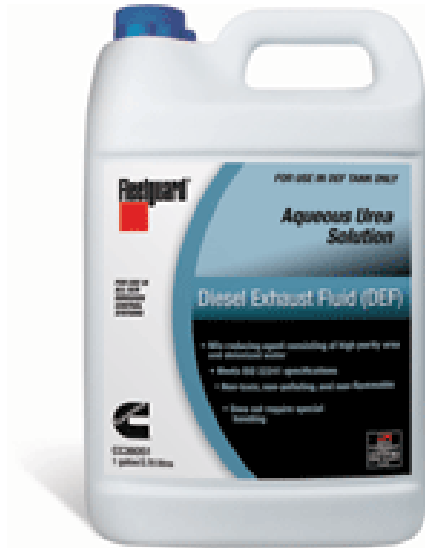
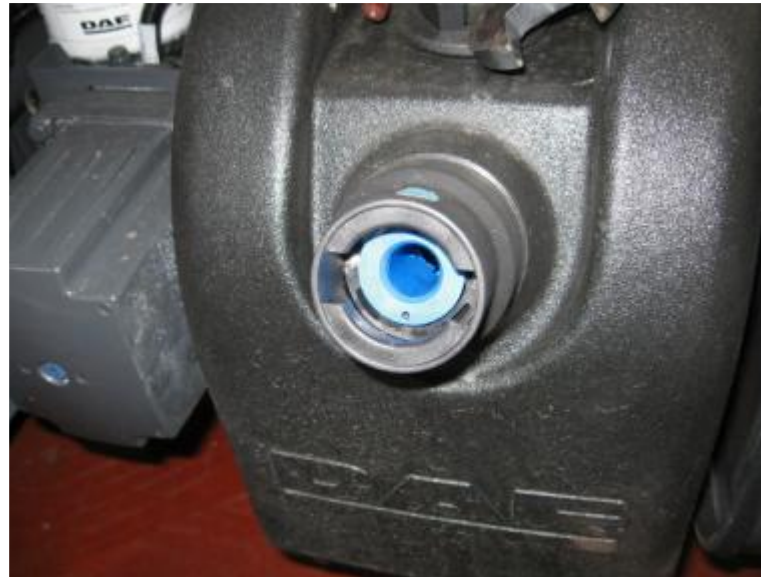
FC1673

No urea in urea tank

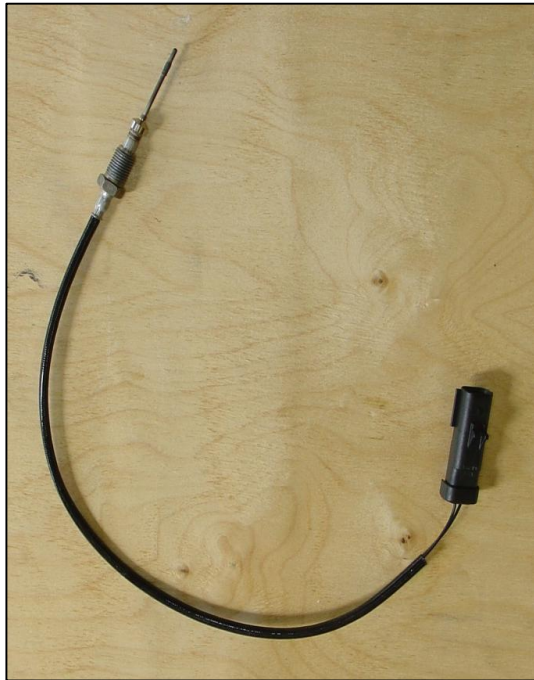
FC3163

- The most likely cause of this fault code is that the SCR intake and outlet temperature sensor connectors are swapped at the engine harness. The catalyst temperature sensors must be reading ambient temperature and the engine must be off for a period of eight hours before this diagnostic will run.
